# Single Survey

**The Mission Hall  
Tongue  
Lairg  
IV27 4XF**

<b>Customer</b>	Mr & Mrs Hunter
<b>Customer Address</b>	The Mission Hall Tongue Lairg IV27 4XF
<b>Date of Inspection</b>	16 <sup>th</sup> April, 2019
<b>Prepared by</b>	Keith Bowman BSc. MRICS

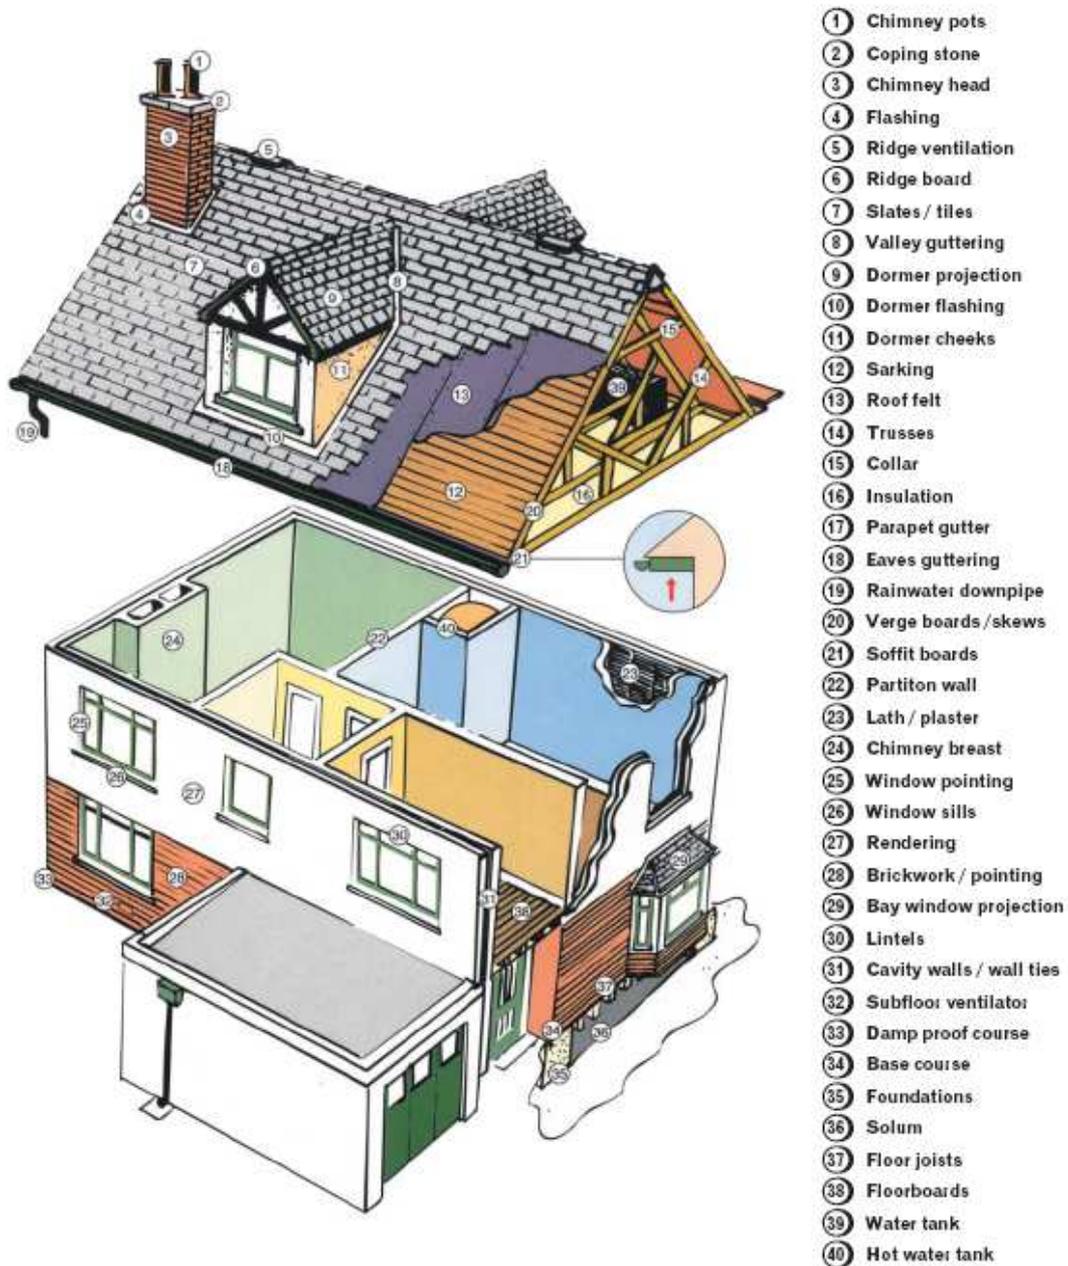
**Sectional Diagram showing elements of a typical house**

Reference may be made in this report to some or all of the above component parts of the property. This diagram may assist you in locating and understanding these items.
